# New York State Department of Transportation

## Yellow Flag NB2228W021

**BIN: 1065318**  
**Feature Carried:** 278I278IX2M23027  
**Feature Crossed:** 6TH AVENUE  
**Orientation:** 8 - NORTHWEST  
**Region:** 11 - NEW YORK CITY  
**County:** KINGS  
**Political Unit:** City of NEW YORK  
**Approximate Year Built:** 1962  
**Posted Load Matches Inventory :** Yes  
**Bridge Load Posting (Tons) :** Not Posted for Load  
**Primary Owner:** New York State Department of Transportation  
**Primary Maintenance Responsibility:** 12 - State - Subcontracted to another Party  
**Typical or Main Span Type:** 3 - Steel, 02 - Stringer/Multi-Beam or Girder  
This Bridge is not a Ramp  
**Number of Spans:** 322

Yellow Flag No. NB2228W021

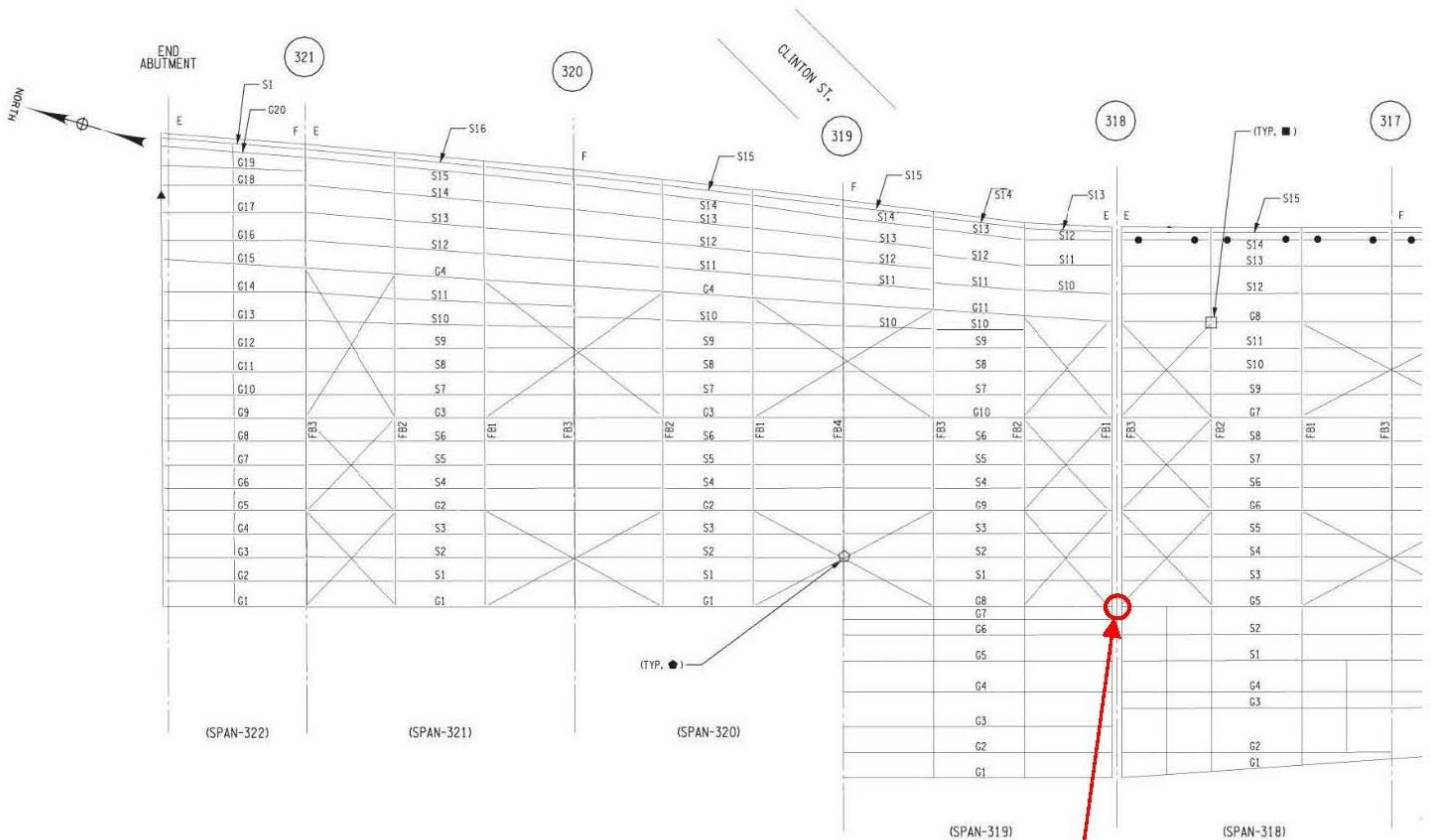
Photo Number: 1

**YELLOW FLAG  
LOCATION**

**No. NB2228W021**

**Attachment Description: SN 318 Pier 318 Column C3 Framing Plan**

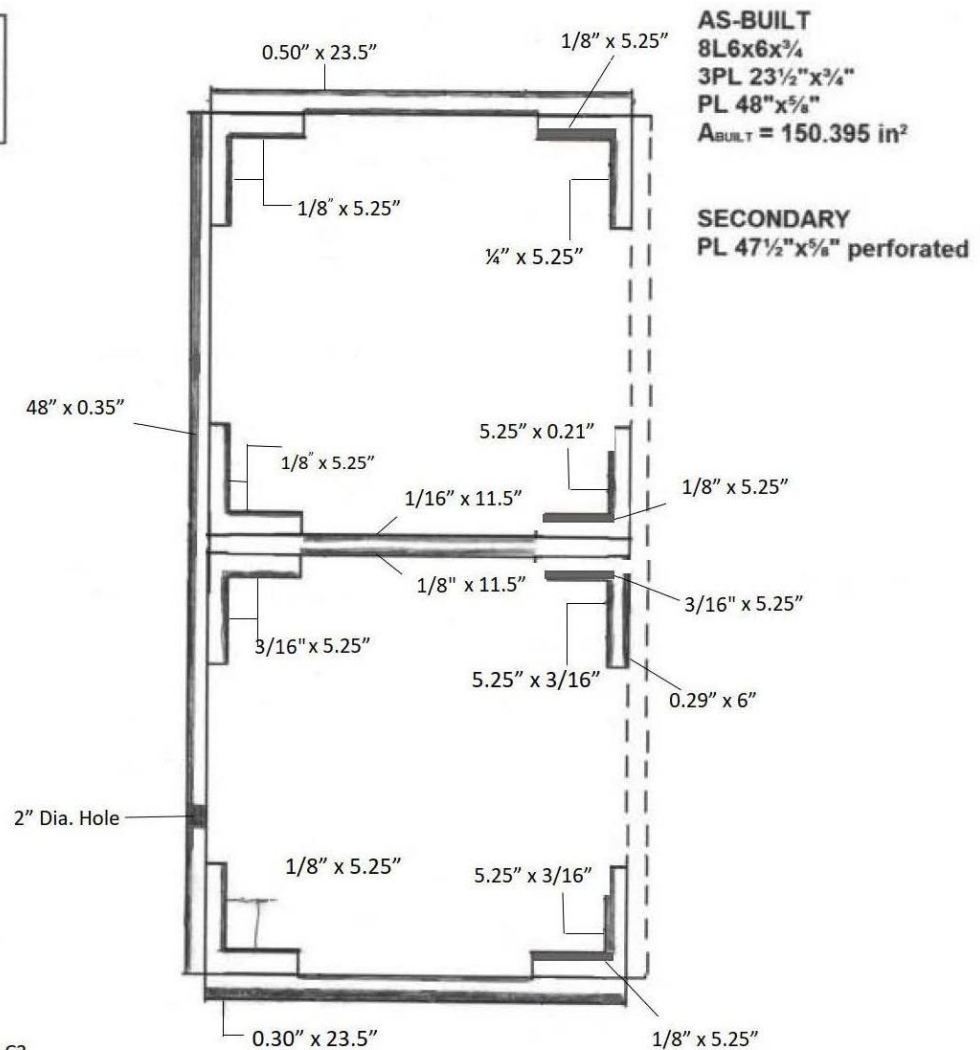
Photo Number: 2

Description: Column C3 exhibits 35% (previously 34%) overall section loss at the base of the column interface with the concrete encasement, with a 2" diameter. corrosion hole above the concrete encasement. There has been no significant changes since the previous inspection.

Section Loss – Column C3  
(at Base)

Overall Section Loss –  $52.74 \text{ in}^2$

Original As Built area –  $150.4 \text{ in}^2$

Overall Section loss – 35%

Secondary Plate at right face was not included in calculations

**Attachment Description: SN 318 Pier 318 Column C3 Sketch**

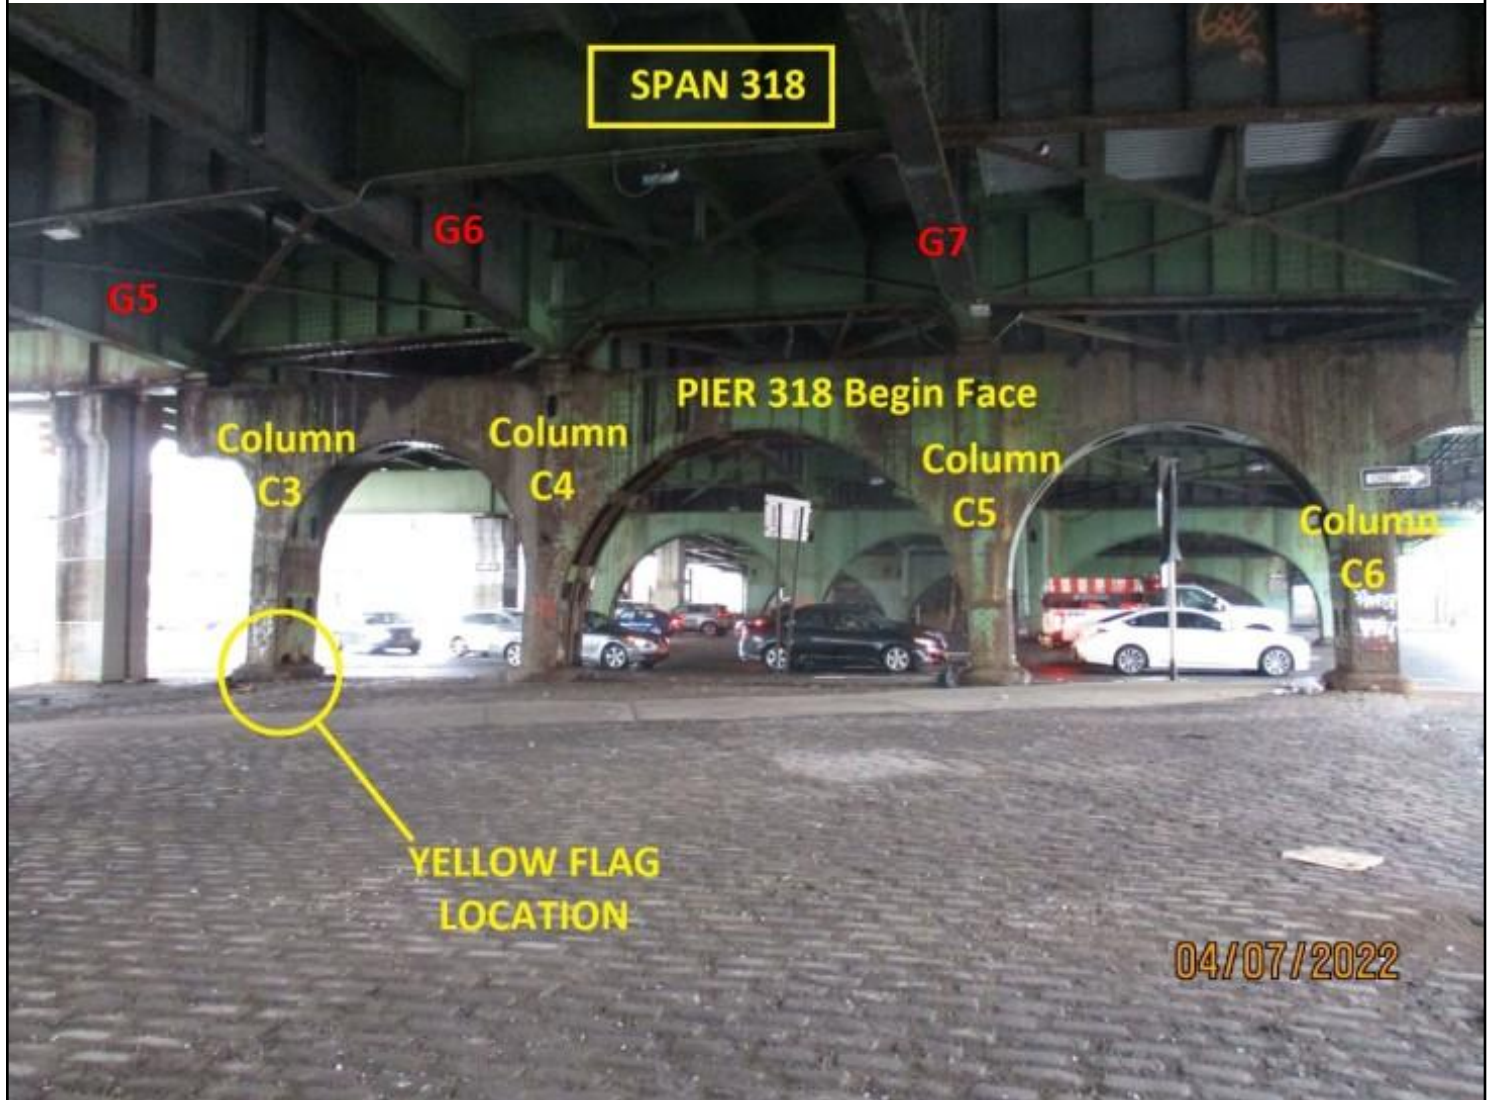
Photo Number: 3

**Attachment Description:** Pier 318 Begin Face. General view of the flagged location. Looking End.

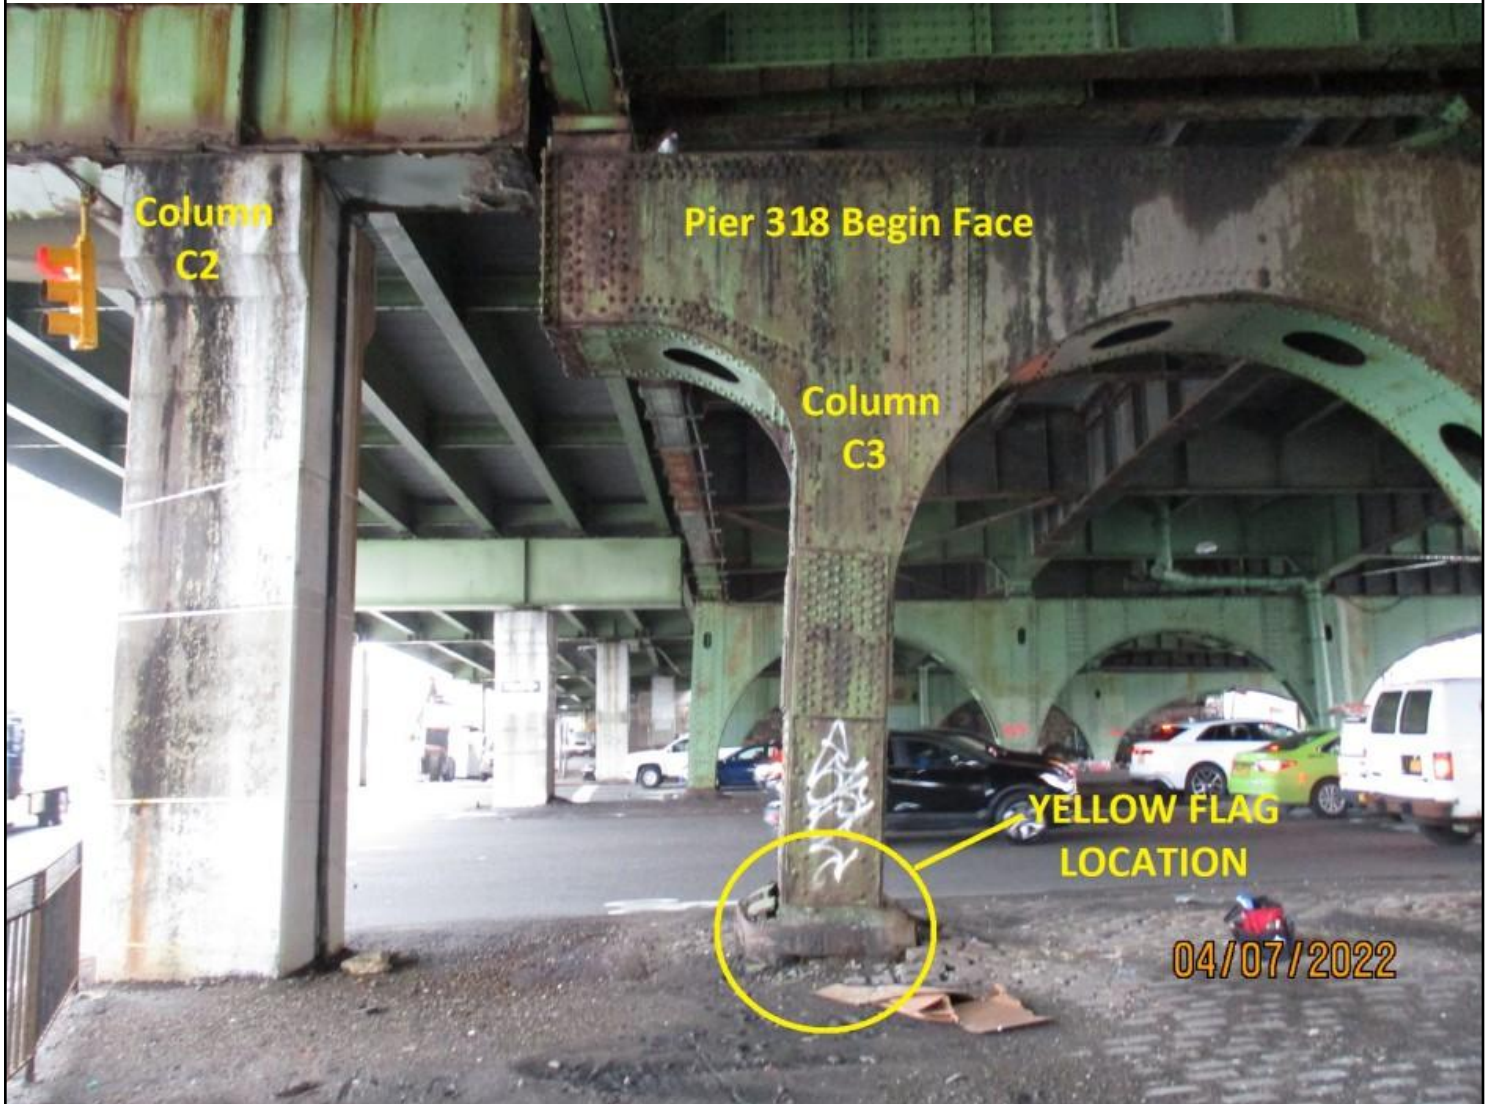
Photo Number: 4

**Attachment Description:** Span 318, Pier 318 Begin Face. General view of the flagged location. Looking End.

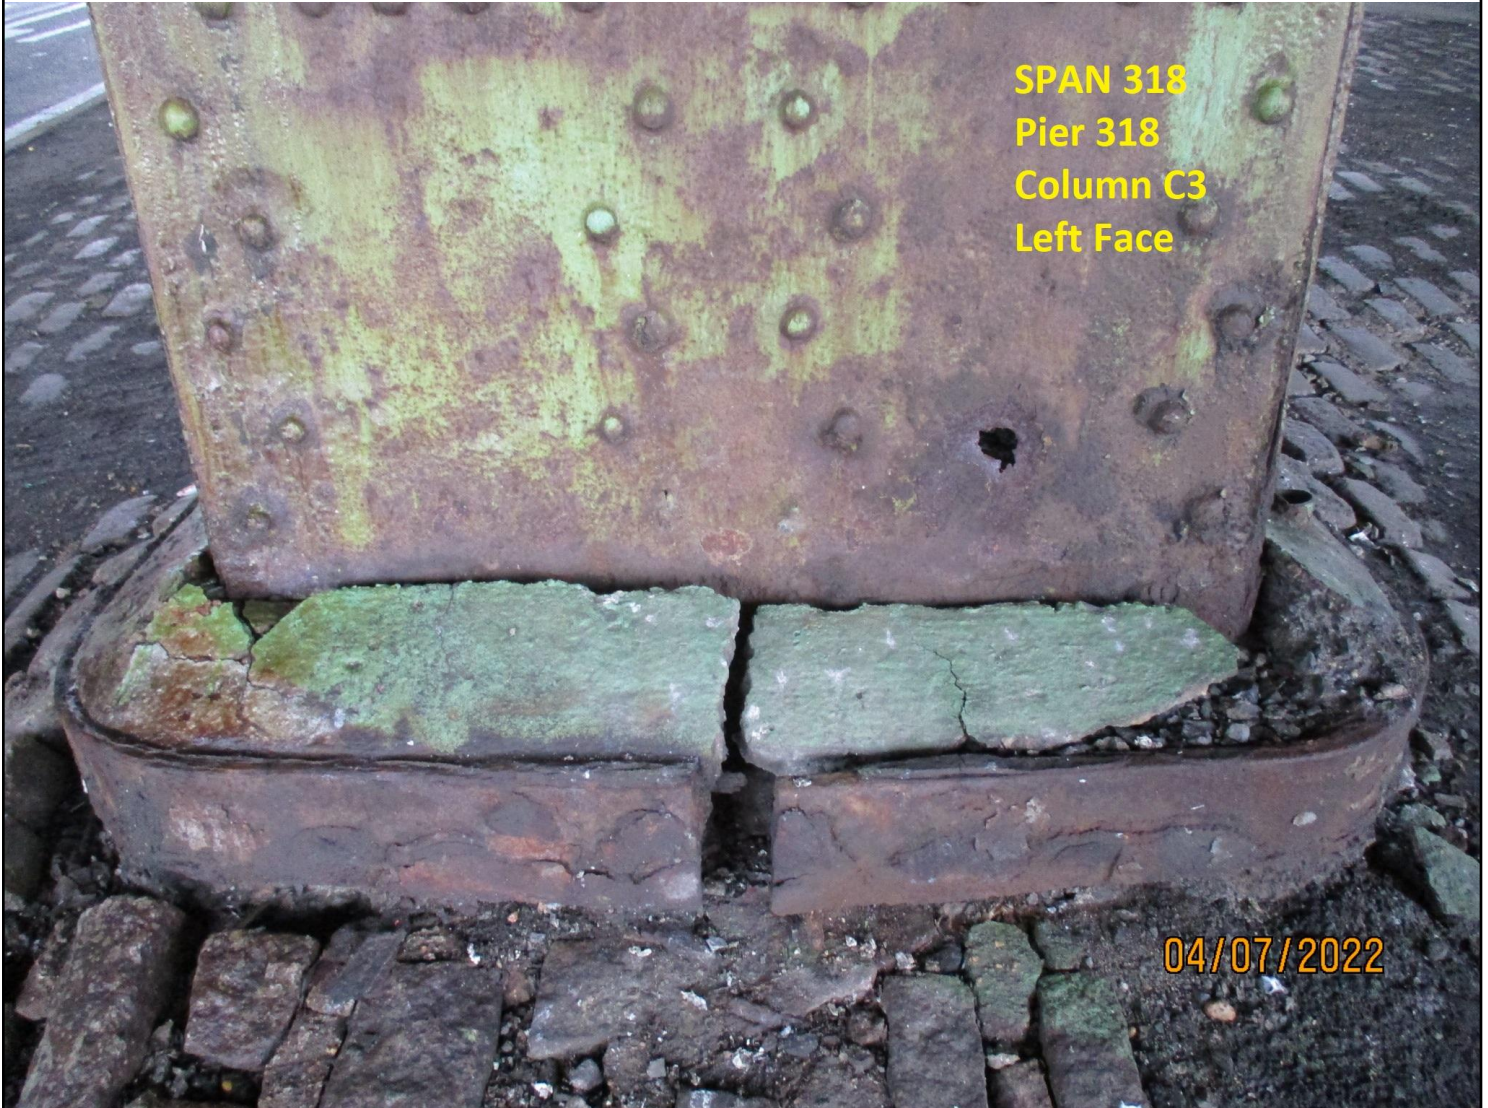
Photo Number: 5

**Attachment Description:** Span 318, Pier 318 Column C3 Left Face. Heavy pitting and 2" Diameter corrosion hole. Looking Right.

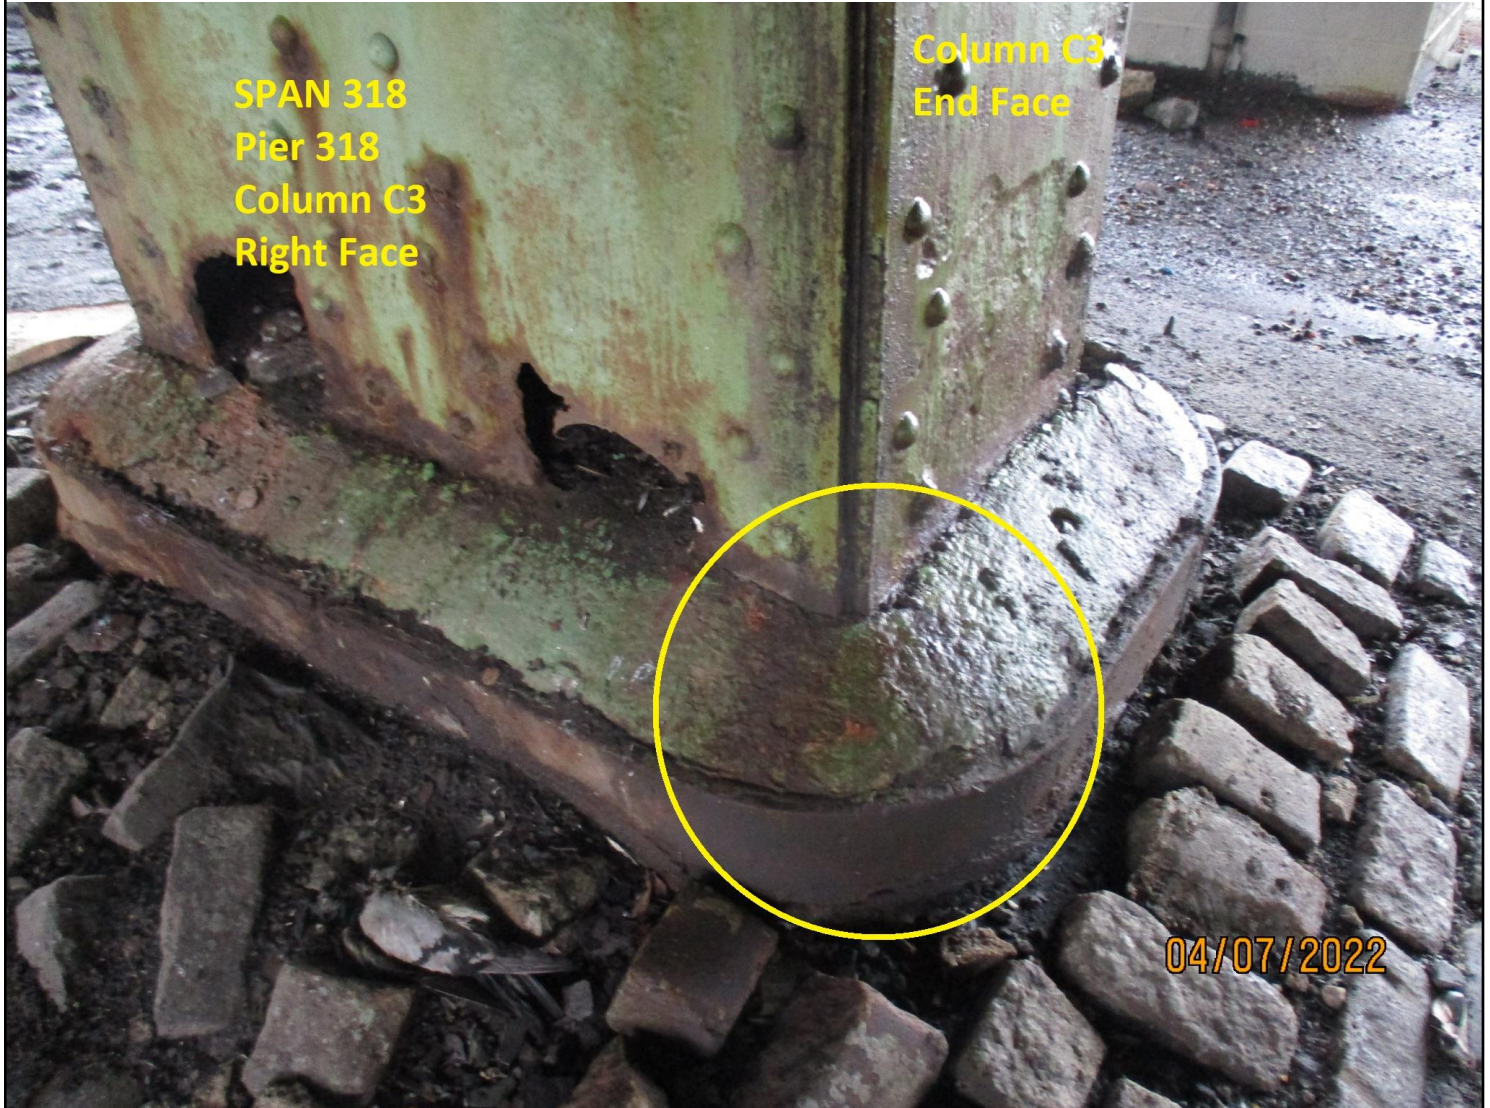
Photo Number: 6

**Attachment Description:** Span 318, Pier 318 Column C3 End and Right Faces. Heavy pitting and signs of active leakage. Looking Begin Left.

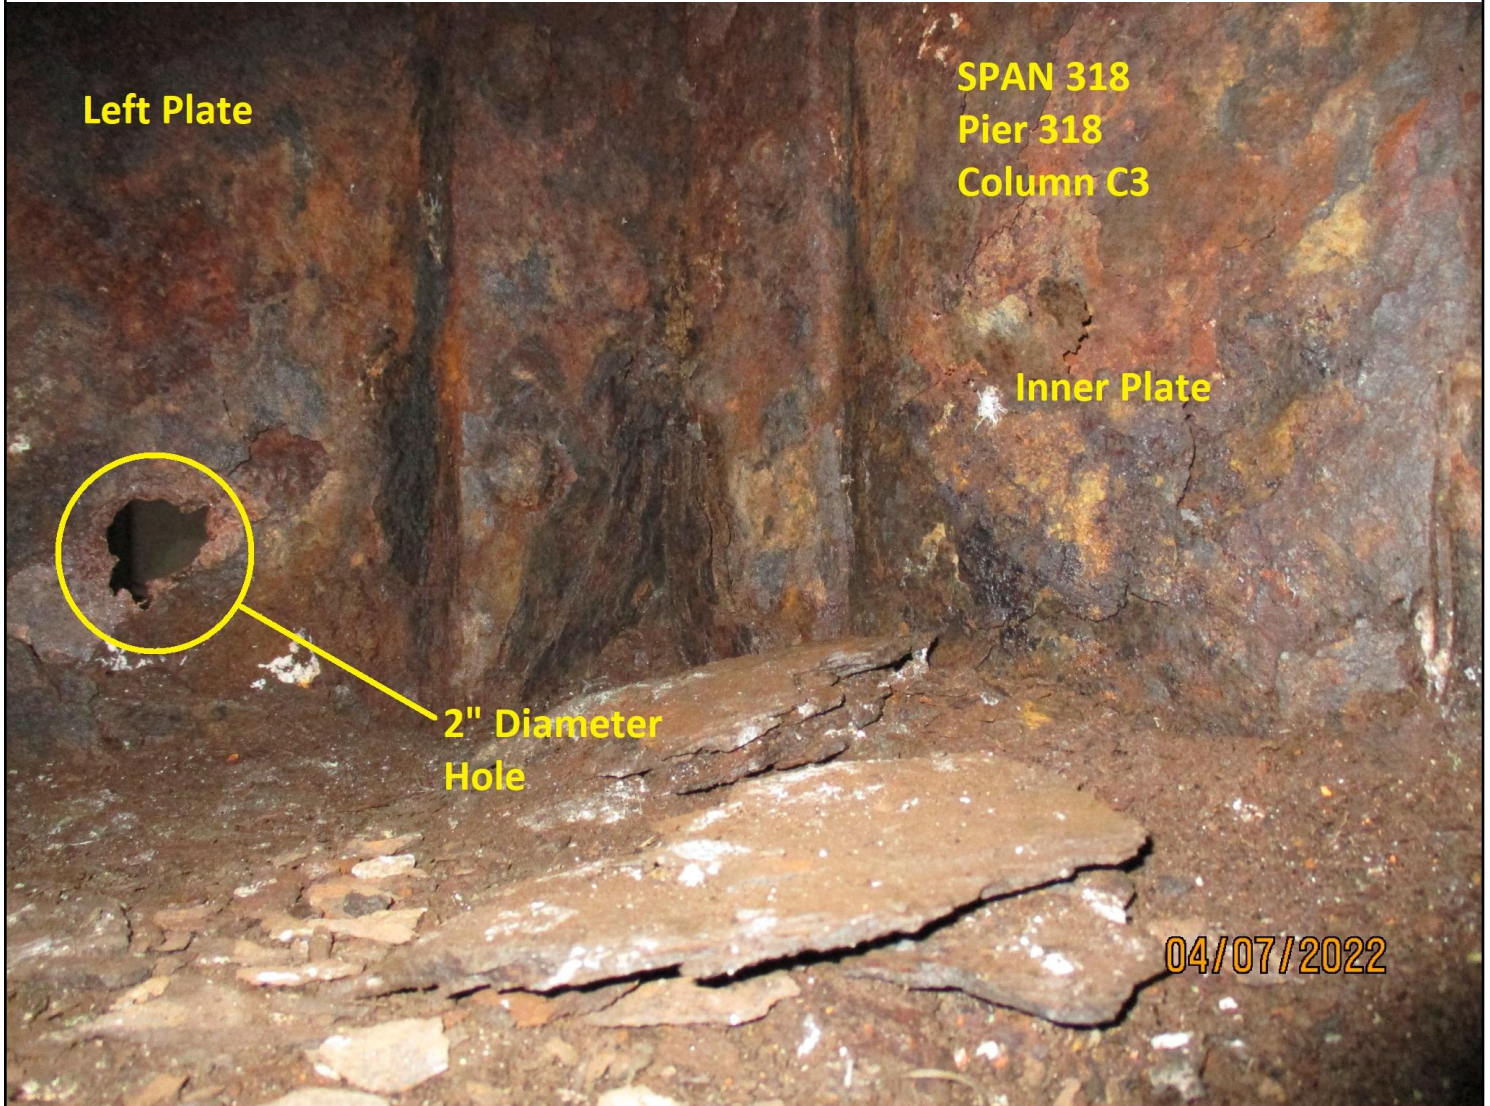
Photo Number: 7

**Attachment Description:** Span 318, Pier 318 Column C3. Close-up view inside the begin portion of Column C3. Heavy pitting and 2" diameter hole. Looking Begin Left.
